**PRELIMINARY ASSESSMENT/
VISUAL SITE INSPECTION**

**GENERAL SIGNAL CORPORATION'S
SOLA ELECTRIC FACILITY
ELK GROVE VILLAGE, ILLINOIS**

**ILD 092 430 719
FINAL REPORT**

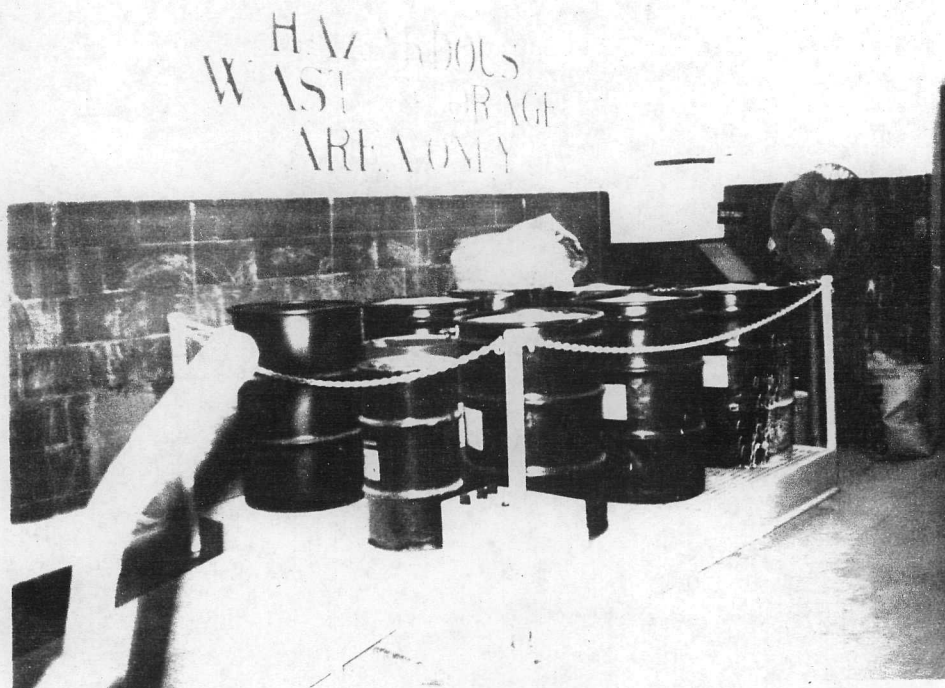
Photo No.:
Orientation:
Description:

The Paint Vault is located indoors on the south side of the building and is used for the collection of hazardous waste generated by the painting operations. The unit consists of a 35-foot by 20-foot room with concrete block walls and a concrete floor with no floor drains (See Photo No. 1).

During the VSI, Dynamac observed five drums of combined paint/spent solvent waste (F003, F005, D001, D035) and three drums of lubricating oil (product). The drums were stored closed and appeared to be in sound condition. There were no stains or evidence of a previous release.

1
North
Five 55-gallon drums containing hazardous waste located on top of a spill container in the Paint Vault.

Location: SWMU 2
Date: April 23, 1992

No further actions are recommended at this time.

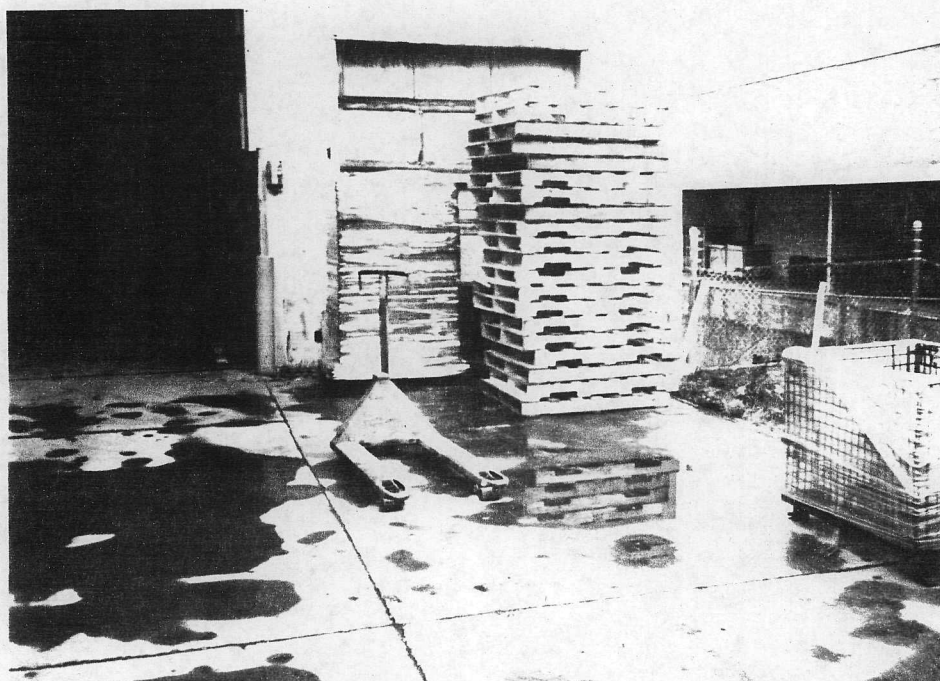
Photo No.: 4
Orientation: East
Description: Location of the Former Storage Area. The wood pallets in the photograph are being stored for future use at the facility.

Observations: During the VSI, Dynamac observed the concrete pad where the unit was formerly located. The concrete pad appeared to be intact with no cracks, stains, or visual evidence of a previous release (See Photo Nos. 3 and 4).

Location: SWMU 10
 Date: April 23, 1992

No further actions are recommended at this time.

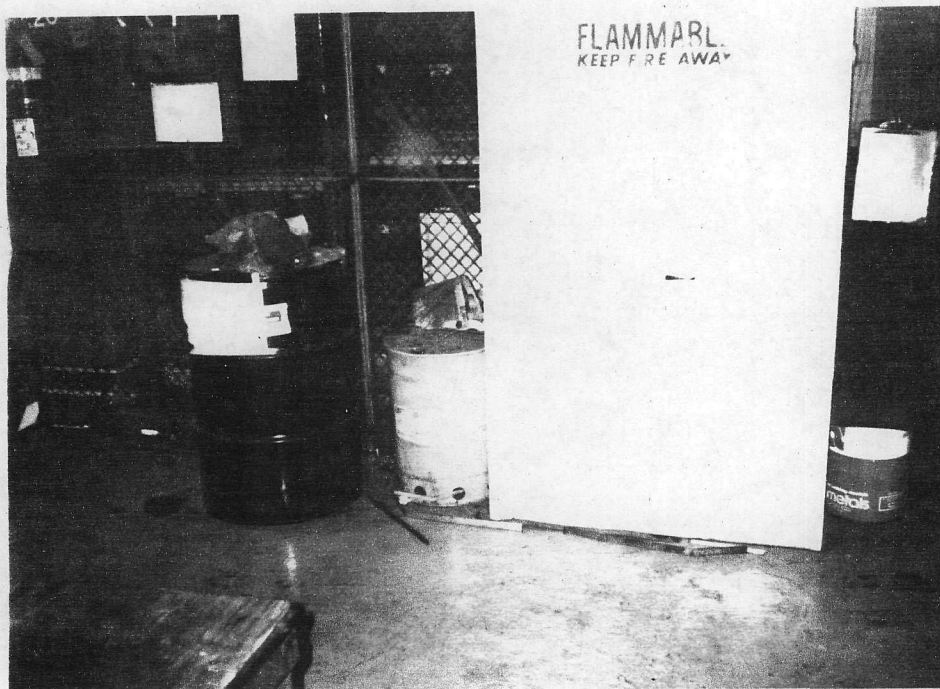
7
North

Although the unit has not been used since approximately 1989, Dynamac observed the empty Solder Dross Bucket at the time of the VSI. The unit appeared to be in sound condition and there were no stains or evidence of a previous release in the surrounding area (See Photo No. 7).

Location: SWMU 9
Date: April 23, 1992

The 5-gallon Solder Dross Bucket located in the circuit board area near the center of the building.

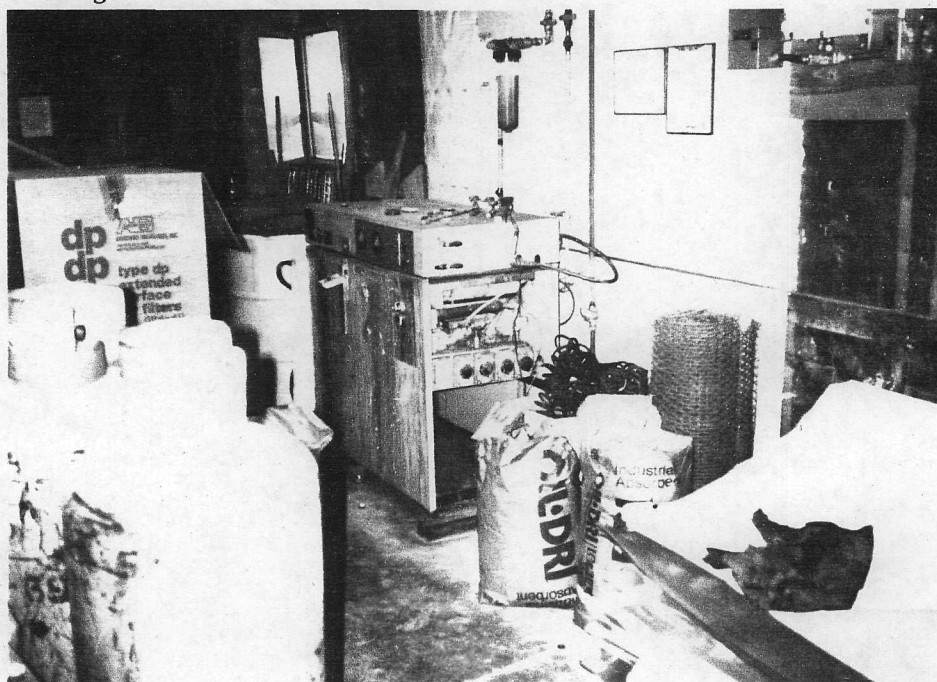
8
West

Dynamac observed the solvent reclamation still during the VSI. The 55-gallon drum normally located adjacent to the still, was not present because the unit has been inactive since 1987. There were no stains or evidence of a previous release in the surrounding area (See Photo No. 8).

Location: SWMU 8
Date: April 23, 1992

The solvent still located in the Solvent Still Area near the south side of the building.

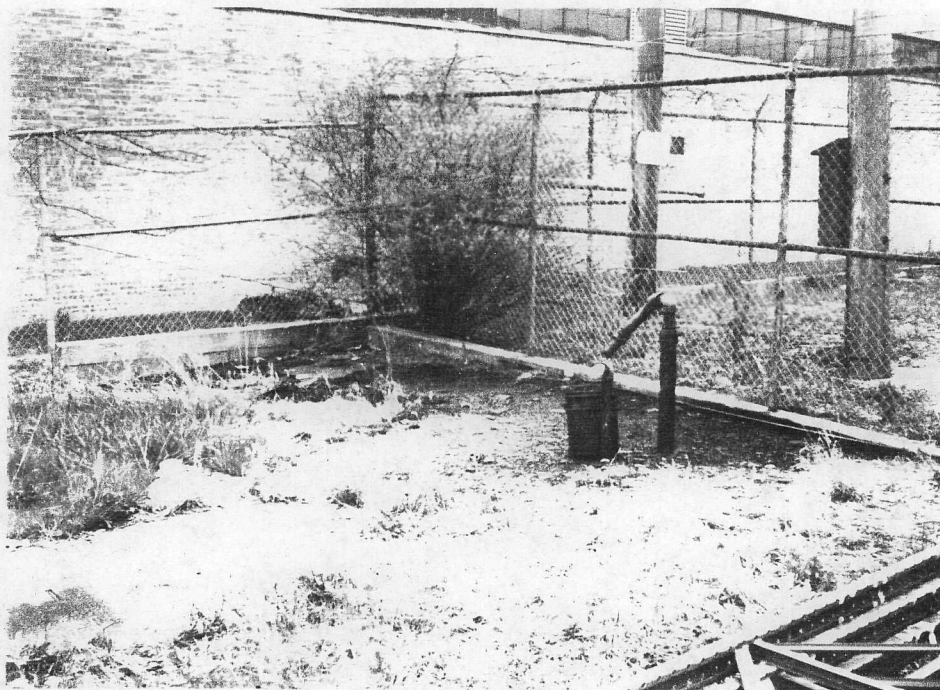
Photo No.: 11

Sola maintains two No. 2 fuel oil underground storage tanks (UST) located outdoors, on the south side of the building (See Figure 2 and Photo No. 11). According to facility representatives, Sola checks the USTs daily with a volume monitoring gauge and there has been no evidence of loss. During the VSI, Dynamac observed an area of Stained Surface Soils (AOC 1) in the vicinity of the USTs.

During the VSI, Dynamac observed an area of Stained Surface Soils (AOC 1) on the south side of the building, near a pipe connected to the two No. 2 fuel oil USTs. The stain measured approximately 18 feet by 8 feet and appeared to be a result of spilled fuel oil from the pipes connected to the USTs (See Photo No. 11). According to facility representatives, the USTs are checked daily with a volume monitoring gauge and there has been no evidence of a loss. Sola is planning on removing the USTs in the summer of 1992. The Stained Surface Soils are identified as an AOC because the stain indicates a release to the environment. In addition, the surrounding vegetation is stressed.

Orientation: Southwest

Dynamac recommends that the facility conduct soil sampling in the vicinity of the AOC for benzene, toluene, ethylbenzene, and xylene (BTEX), polynuclear aromatic compounds (PNAs), and any other hazardous constituents generated or managed at the facility.
